LAST RESORT FARM NOT STALLED BY DAIRY BARN CONVERSION FOR PRODUCE

About the Project

Overview: Renovation of an existing dairy barn. Turning an area of 23'x68ft (1,950 sq. ft) into washing, packing and storage space.

April 2018—v 1.0

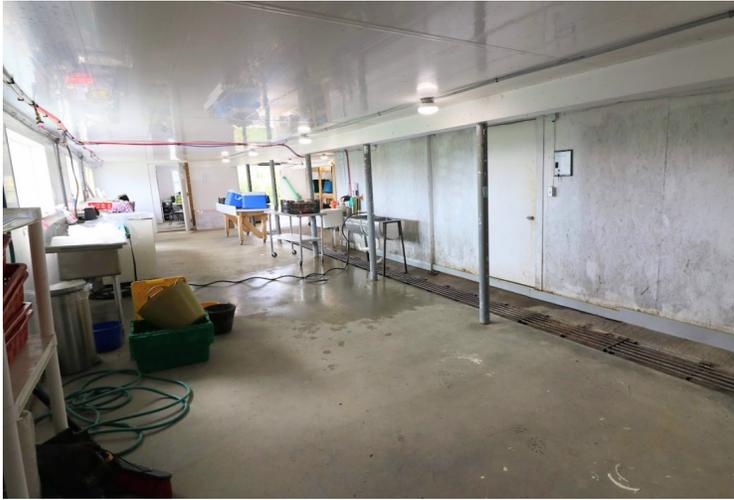
▲ Ceilings are finished with [Trusscore](#), covering up existing flaking paint and enclosing new insulation. Cooler walls painted white, large south facing windows, and an “open” floor plan makes for a bright and useful working environment.

Another key feature was cleanability. Installing smooth cleanable surfaces allows the space to be cleaned well on a regular basis. He used [Trusscore](#) as a finish material on inside walls. This is easy to install and doesn't require any sheathing behind it. It’s not cheap but Silas worked the numbers and noted, “Based on labor savings it seemed to come up on top.”

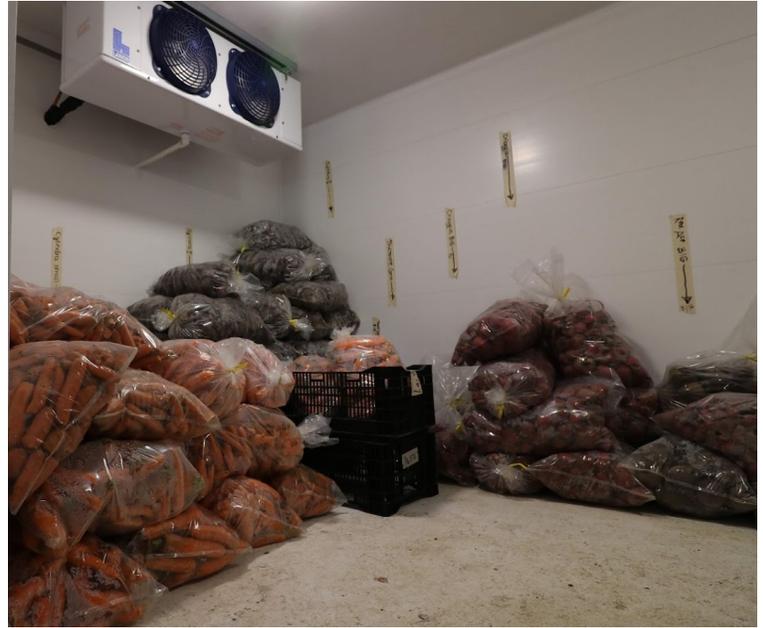
▲ This cooler is equipped with a commercial split refrigeration system and used when there needs to be a lot of field heat removed quickly. Shelves are planned, but temporary organization is accomplished with masking tape.

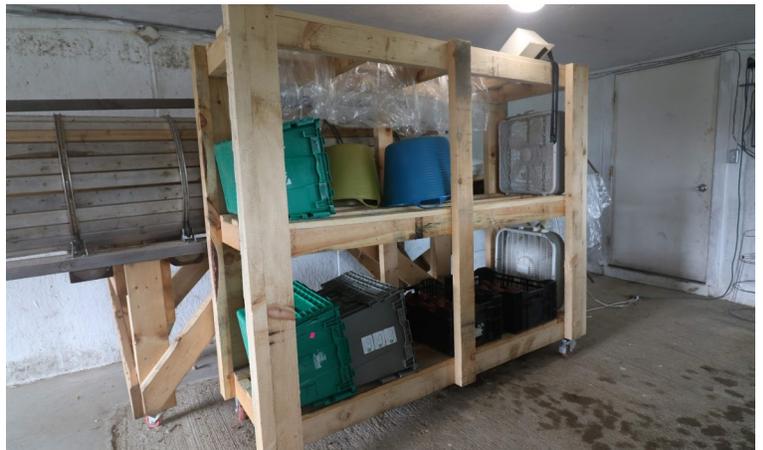
▲ A custom DIY rack for drying and storing totes. Both the rack and the barrel washer on wheels for flexibility and easy mobility.

Installing casters on the main equipment (tables, barrel

washer, greens spinner) makes the set-up of different jobs in the wash-pack space quick and easy to transition between crops.

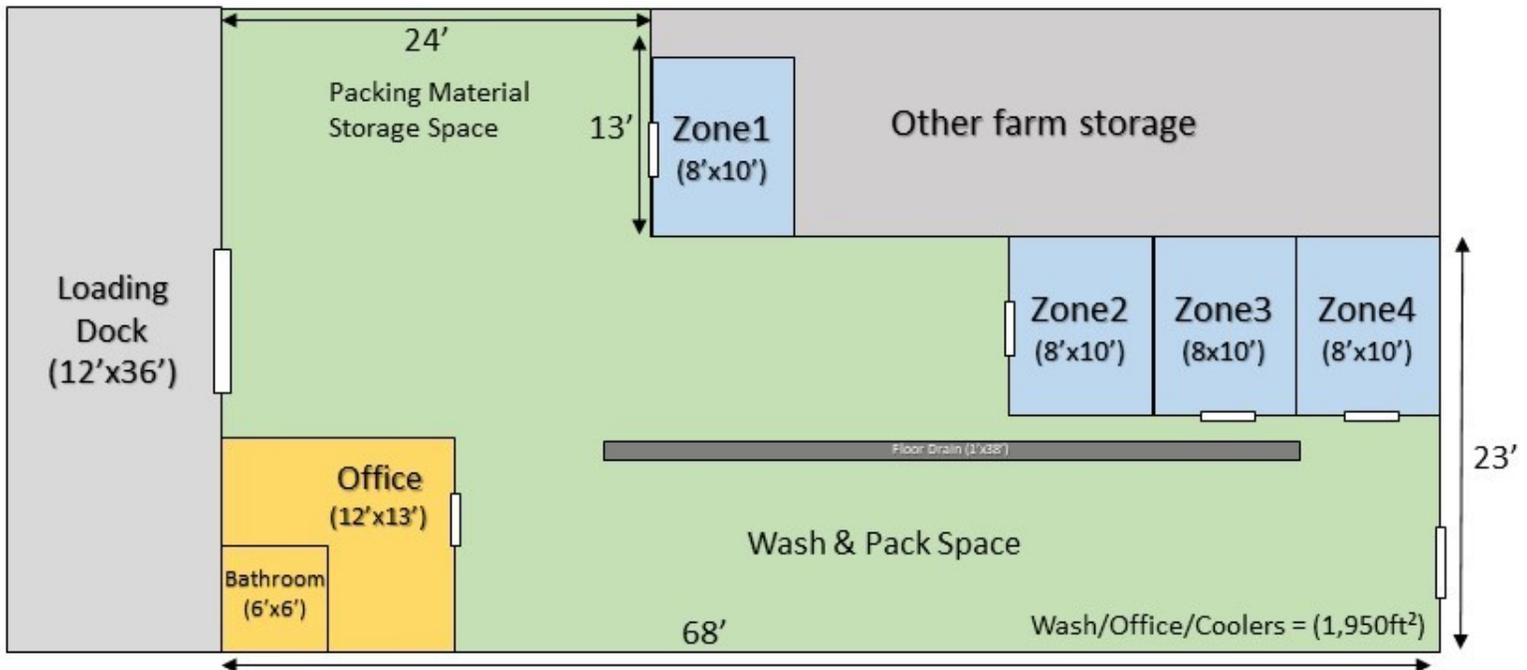
▲ This floor plan shows the basic layout and use of about half of the barn use for vegetable washing, packing and storing.

Silas was thinking about intentional flow at the start of the project. He wanted a space where product comes in at one end (gets cleaned, packed, stored) and is delivered out the other. The addition of a loading dock provides the ability to move pallets and pallet bins of product which was not possible before.

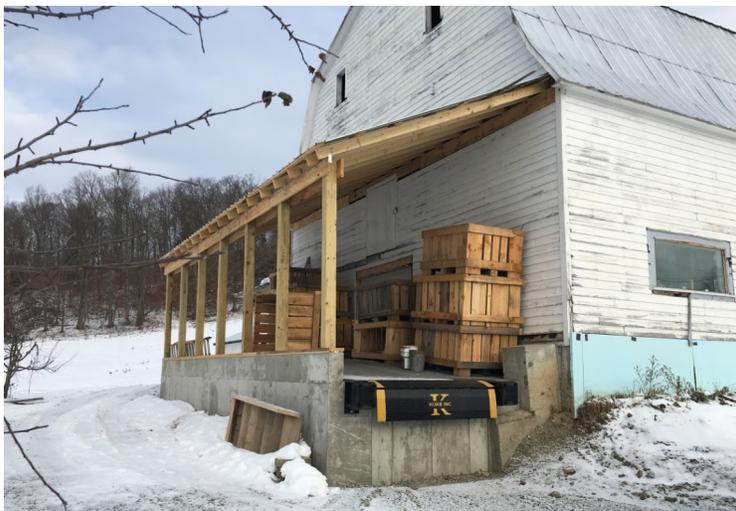
▲ The renovations included installing a covered loading dock, with a dock leveler. This enables easy wholesale transactions and adds additional outdoor covered storage.

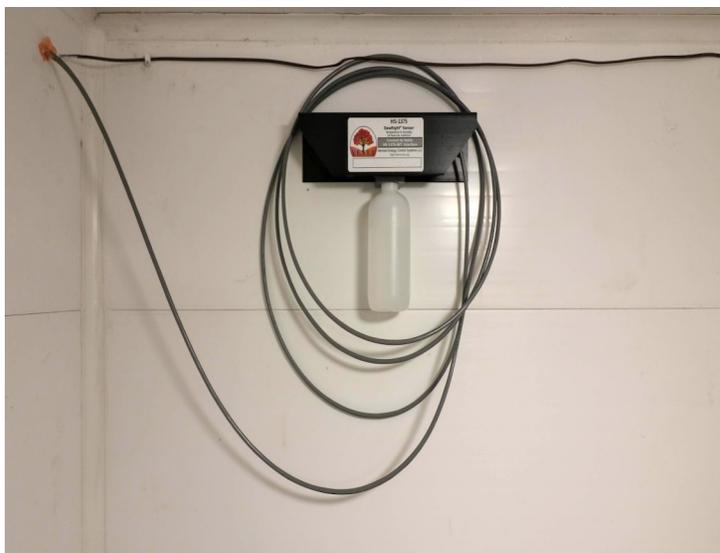
▲ The DewRight Humidity sensor accurately measures and reports the relative humidity to a computer which controls humidifiers to optimize storage conditions to ideal set points for storage crops.

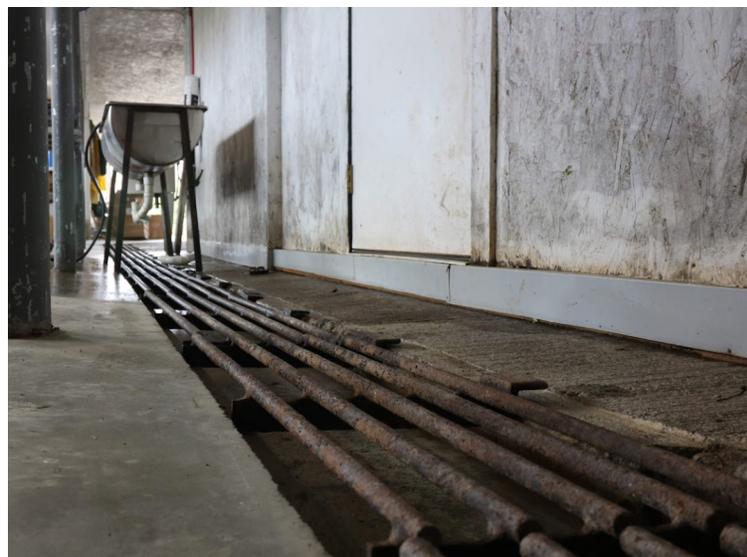
▲ Silas utilized the existing gutter of the dairy barn for wash water catchment. Some chiseling/grading and installation of a clean-out was needed to manage the sediment.

maintain was an important factor to reduce food safety risk. Cleaning out the sediment trap is a labor intense job that has to be done periodically when washing heavily loaded crops.

A “gutter” style trench drain and floors pitched to it. Using a 2% slope, water and debris easily find their way to the gutter which can be cleaned out on a routine basis. “I think that that’s actually the most important feature that we have here,” noted Silas pointing to the drain.
